Tennessee Valley Authority, Post Office Box 2000, Decatur, Alabama 35609-2000

**BROWNS FERRY NUCLEAR PLANT (BFN) - UNIT 3 - DOCKET NO. 50-296 -
FACILITY OPERATING LICENSE DPR-68 - LICENSEE EVENT REPORT
(LER) 50-296/2000-005-00**

TITLE (4)
Scram During Level Transmitter Calibration

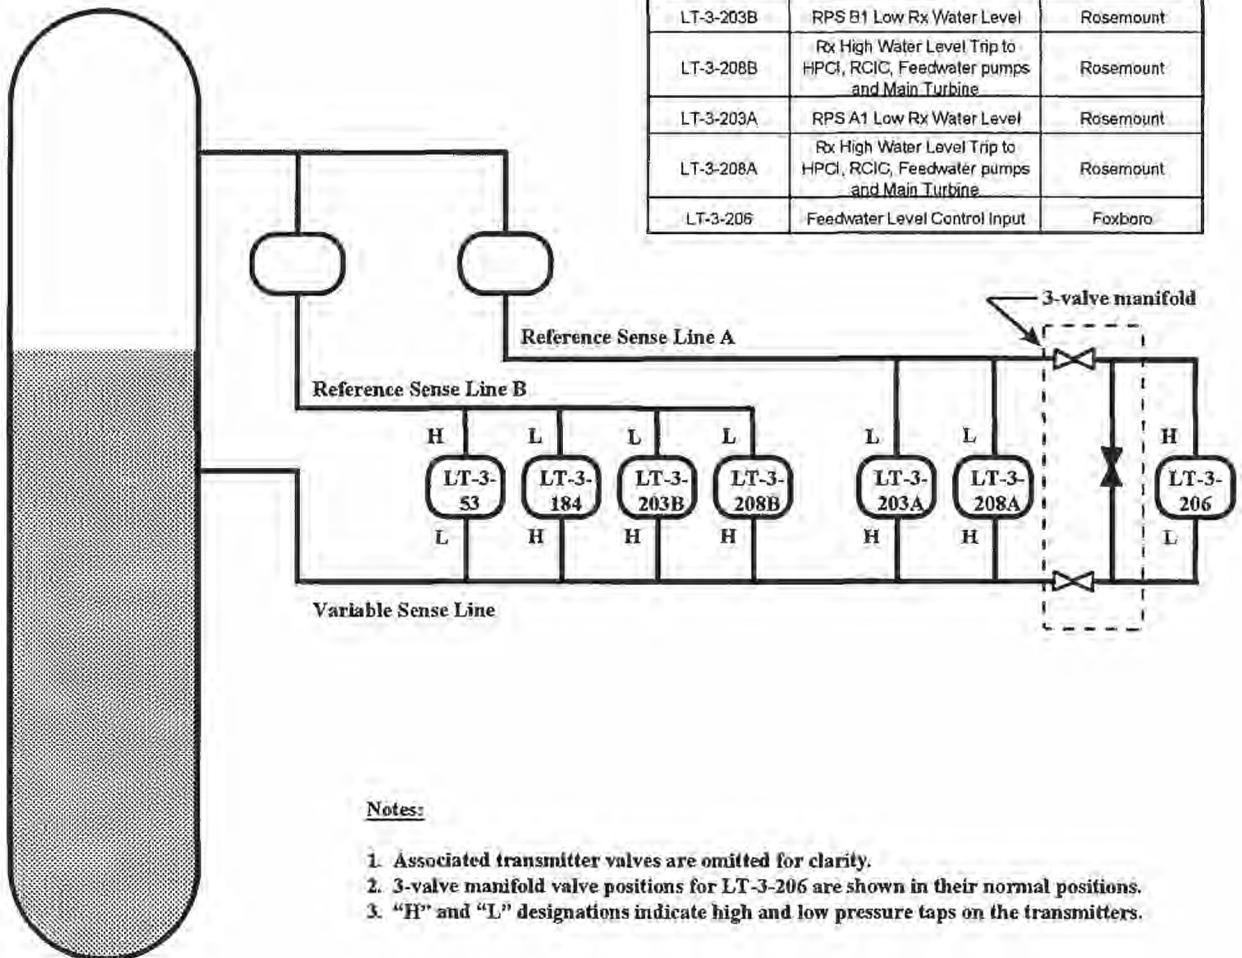
ATTACHMENT 1
Reactor Vessel Level Transmitter Arrangement
(Half of all transmitters shown for clarity)

The immediate cause was a pressure perturbation in the sensing line to reactor water level instruments that sensed a low reactor water level in both channels of the reactor protection system (RPS).

The root cause of this event was determined to be lack of a specific proceduralized valving sequence for this level transmitter to reduce the risk of inducing a perturbation into the reactor instrument sensing lines.

The reactor scram occurred while Instrument Mechanics were returning a feedwater level transmitter, 3-LT-3-206 (Foxboro), to service following scheduled calibration. This transmitter shares a common sensing line (variable leg) with other reactor narrow range level transmitters (Rosemount) that input to the RPS (see Attachment 1). Due to the type of sensing element used on the Foxboro transmitters, their process connections are reverse that of the Rosemount transmitters. By design, the RPS transmitters use separate reference sensing lines but share a common variable sensing line. This feature combined with a specific valving sequence included in RPS procedures, but not in the feedwater transmitter calibration procedure, prevents a full scram in the event of a pressure perturbation while returning a transmitter to service. When 3-LT-3-206 was being returned to service, its low side manifold isolation valve (variable leg) was first opened. This action would pressurize both the high and low sides of 3-LT-3-206 since the manifold equalizing valve was open. While the low side manifold isolation valve was being opened, the scram occurred. Data obtained from an adjacent transmitter, which shares the variable sense line with 3-LT-3-206, indicated reactor water level showed a substantial lowering. This is attributed to the variable sense line pressure lowering while reestablishing pressure to the tubing associated with 3-LT-3-206. Since both RPS transmitters share this same sense line, a momentary low reactor water level scram signal was generated.

The procedure used to calibrate the Foxboro reactor water level transmitters will be revised to contain specific valve sequencing.¹

A design modification will be issued for anti-surge tip isolation valves to be installed on Unit 3 where the Foxboro reactor water level transmitters are used. An evaluation will be conducted for installation of anti-surge tip isolation valves for other transmitters that have common sensing lines which can generate a reactor scram either directly or indirectly.¹
